Global Advanced Research Journal of Environmental Science and Toxicology (ISSN: 2315-5140) Vol. 5(1) pp. 001-008, February 2016  
Available online <http://garj.org/garjest>  
Copyright © 2016 Global Advanced Research Journals

## *Full Length Research Paper*

# **Ecological impact of artisanal and small scale mining in parts of Taraba state, Nigeria**

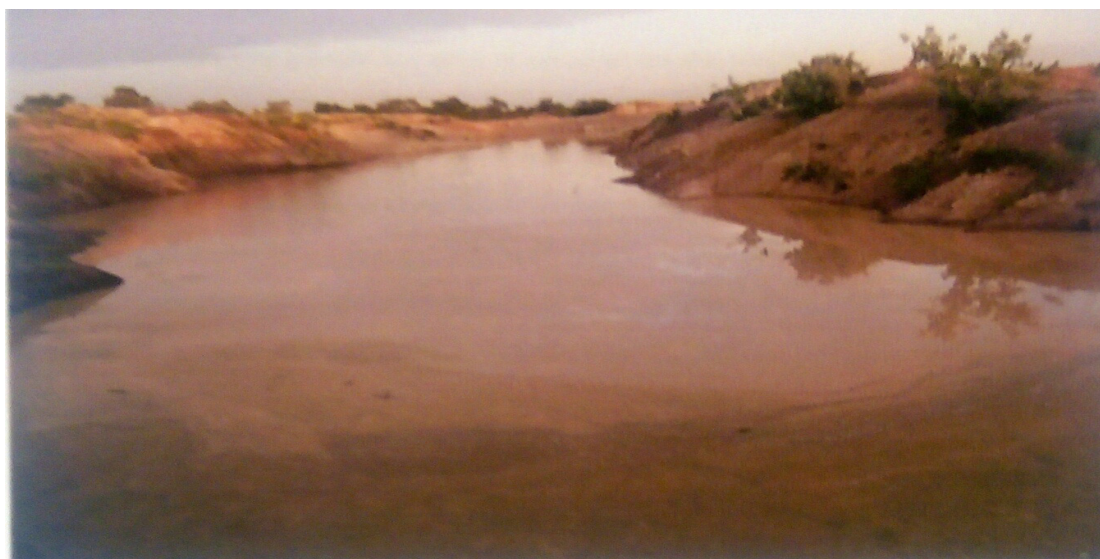
**Plate 1.** Regular - Shaped Trench of Abandoned Baryte Mining Site at Didango

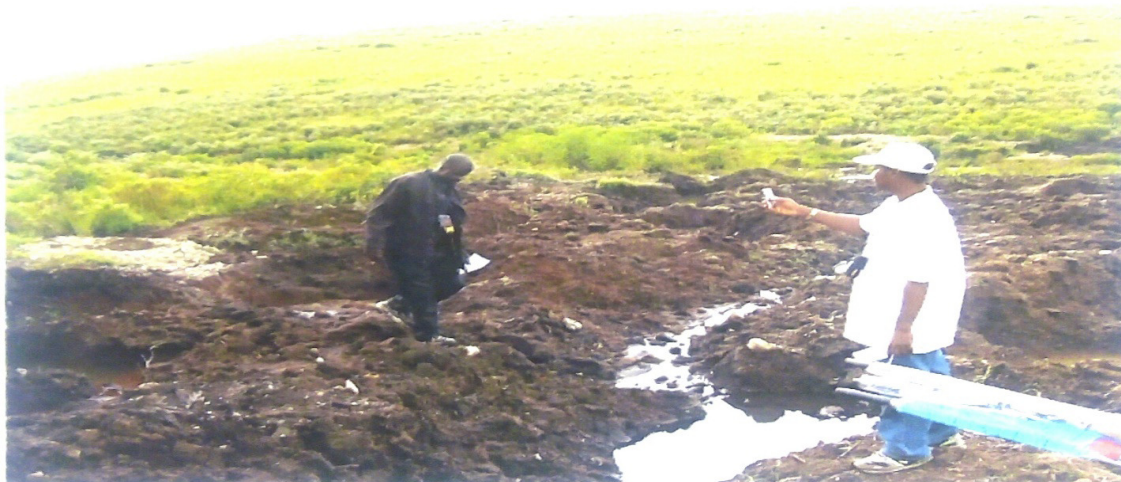
**Plate 2.** Examining Mining Impacts on Stream Channel in Yelwa town

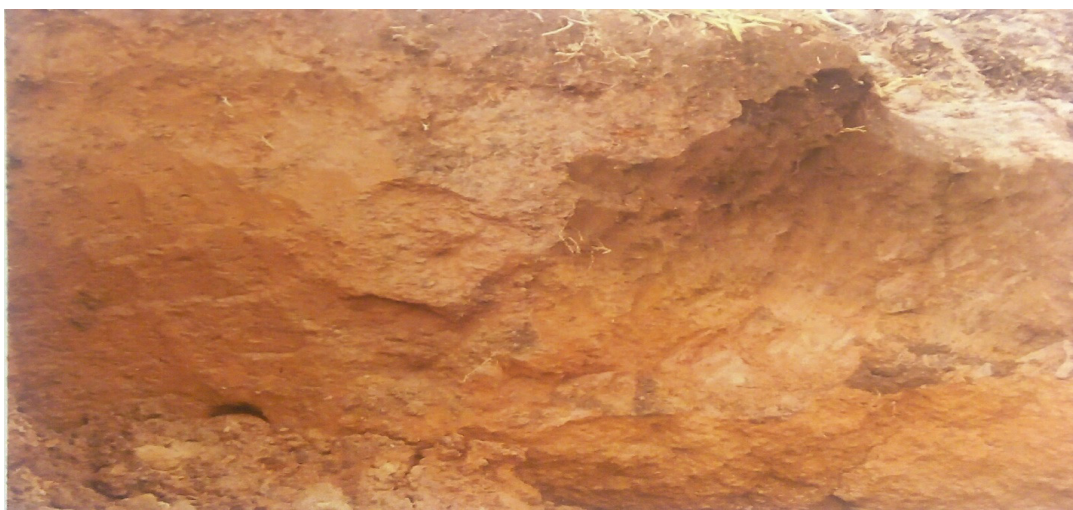
**Plate 3.** Land degradation as a result of Collapse of Mining Walls at Yelwa Mining site

gravels to recover gemstones in some areas resulted in gully erosion. Subsidence was evidenced in areas of old underground “loto” excavations. About 50% of the pits enumerated in the area has lost its smooth topography because of this active subsidence (Plates 3 and 4).

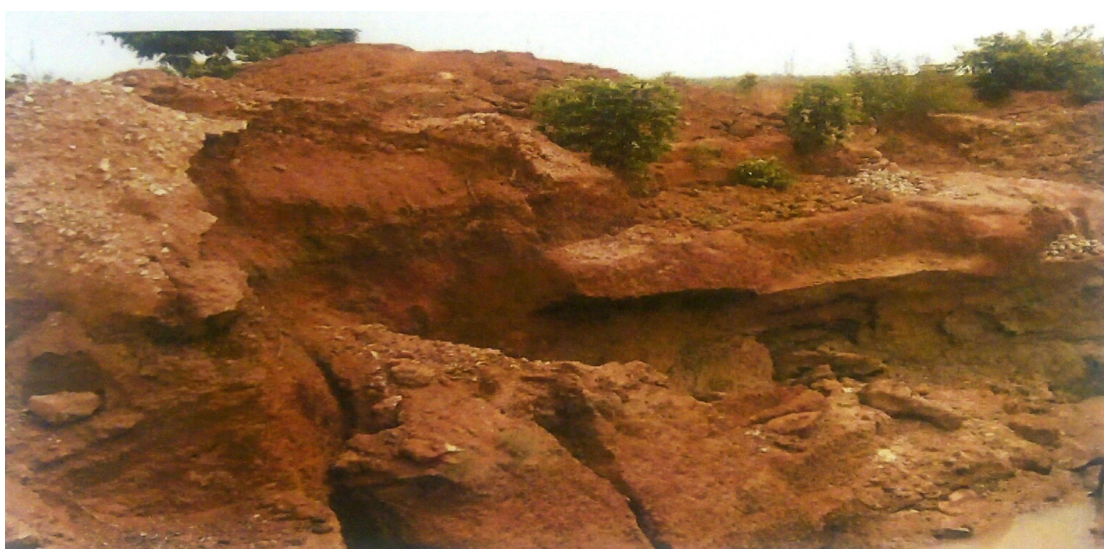
**Plate 4.** Collapse of Walls in a Baryte Mining Pit in Didango, Karim Lamido LGA

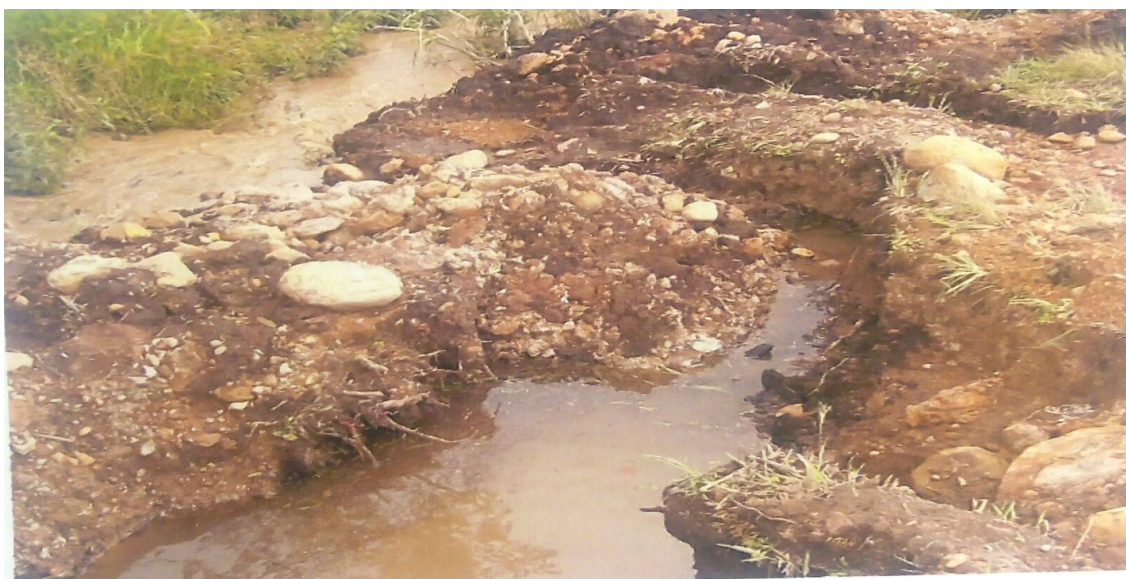
**Plate 5.** Polluted Stream Channel as a result of Mining Activities at Yelwa Mining Site
